**Flood Control Project Maintenance
Levee Inspections**

Maintenance Issue Types Only, Levee Inspection Report By Mile - Spring 2019

Plumas County

Waterway	Bank	Unit Miles	Inspection Start/End	Inspector
Unit No. 01 North Fork Feather River	Left	1.89	05/22/2019 05/22/2019	Sterling York

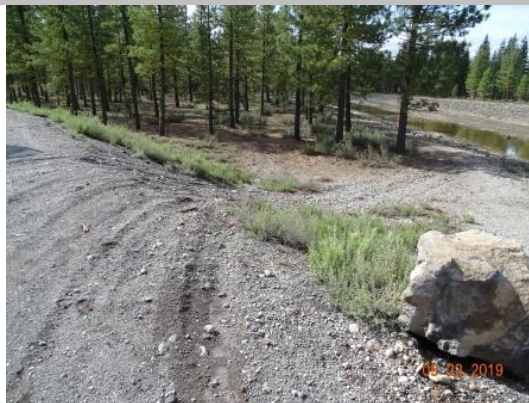
Photo 1 of 1 : SP_2019_NA0015_337_8_20190523_00010.jpg

LM Start	0.54	Rating **	M	Issue No.	8
LM End	0.54	Issue Type +	Ma	Location *	WS
Category	Earthen Levee			GPS Latitude/Longitude	
				Start	End
Item	Slope Stability			40.279775 °	40.279775 °
				-121.249648 °	-121.249648 °
DWR ID	DWR_NA0015_01_f_2018_8				
Comment Code					
S3 : Repair the levee slope damaged by vehicle traffic and prevent access where possible.					
Inspector Comment					
Repair the vehicle erosion on the waterside slope, Spring 2019.

View of vehicle erosion on the waterside slope, Spring 2019

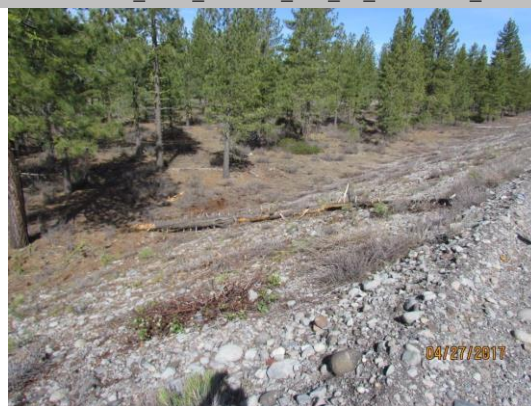
Photo 1 of 1 : SP_2019_NA0015_337_16_20190315_00005.jpg

LM Start	1.17	Rating **	M	Issue No.	16
LM End	1.17	Issue Type +	Ma	Location *	WS
Category	Earthen Levee			GPS Latitude/Longitude	
				Start	End
Item	Encroachments			40.287722 °	40.287722 °
				-121.253510 °	-121.253510 °
DWR ID	DWR_NA0015_01_s_2017_16				
Comment Code					
TR : Tree or limb					
Inspector Comment					
Remove the tree from the landside slope and toe.

View of the tree along the landside slope and toe.

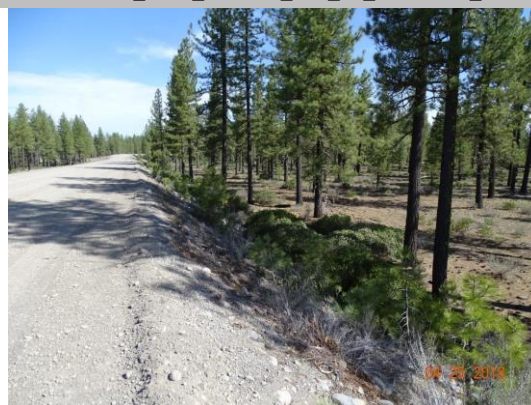
Photo 1 of 1 : SP_2019_NA0015_337_18_20190315_00006.jpg

LM Start	1.24	Rating **	M	Issue No.	18
LM End	1.88	Issue Type +	Ma	Location *	LS
Category	Earthen Levee			GPS Latitude/Longitude	
				Start	End
Item	Vegetation			40.288744 °	40.297068 °
				-121.254147 °	-121.257120 °
DWR ID	DWR_NA0015_01_s_2018_18				
Comment Code					
V2 : Remove the wild growth other than native grasses from the levee slopes.					
Inspector Comment					
Remove the small pine trees and vegetation from the landside slope, Spring 2019.

View of the small pine trees and vegetation along the landside slope.

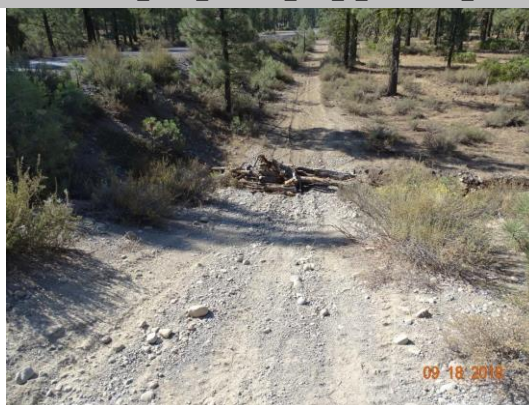
Photo 1 of 1 : SP_2019_NA0015_338_4_20190315_00003.jpg

LM Start	0.55	Rating **	M	Issue No.	4
LM End	0.55	Issue Type +	Ma	Location *	LS
Category	Earthen Levee			GPS Latitude/Longitude	
				Start	End
Item	Slope Stability			40.281950 °	121.253710 °
				40.281950 °	121.253710 °
DWR ID	DWR_NA0015_02_s_2012_4				
Comment Code					
S3 : Repair the levee slope damaged by vehicle traffic and prevent access where possible.					
Inspector Comment					
Vehicle erosion along the landside slope.

View of the vehicle erosion along the landside slope.

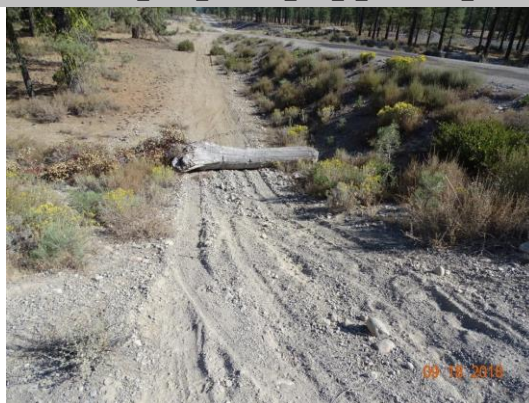
Photo 1 of 1 : SP_2019_NA0015_338_5_20190315_00004.jpg

LM Start	0.55	Rating **	M	Issue No.	5
LM End	0.55	Issue Type +	Ma	Location *	WS
Category	Earthen Levee			GPS Latitude/Longitude	
				Start	End
Item	Slope Stability			40.281950 °	121.253710 °
				40.281950 °	121.253710 °
DWR ID	DWR_NA0015_02_s_2012_5				
Comment Code					
S3 : Repair the levee slope damaged by vehicle traffic and prevent access where possible.					
Inspector Comment					
Repair the vehicle erosion along the waterside slope.

View of the vehicle erosion along the waterside slope.

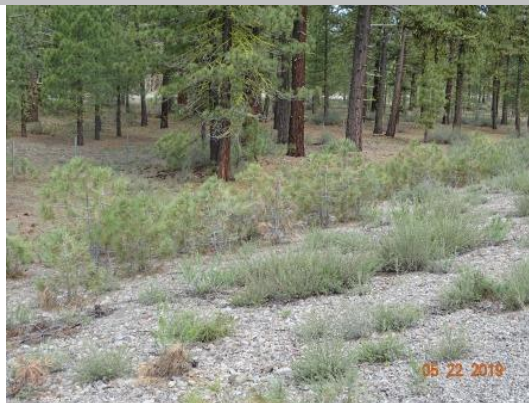
Photo 1 of 1 : SP_2019_NA0015_338_2_20190523_00008.jpg

LM Start	0.98	Rating **	M	Issue No.	2
LM End	1.32	Issue Type +	Ma	Location *	LS
Category	Earthen Levee			GPS Latitude/Longitude	
				Start	End
Item	Vegetation			40.276392 °	40.272219 °
				-121.250420 °	-121.247152 °
DWR ID	DWR_NA0015_02_f_2017_2				
Comment Code					
V2 : Remove the wild growth other than native grasses from the levee slopes.					
Inspector Comment					
Remove the small pine trees and vegetation from the landside slope.

View looking upstream landside of the small pine trees and vegetation along the landside slope, Spring 2019.
